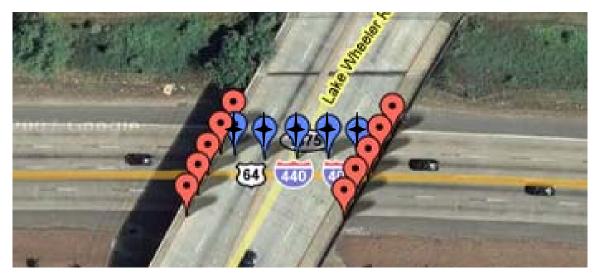
Figure 4.15. Survey and Geo-3D measurement locations for Lake Wheeler Road bridge.

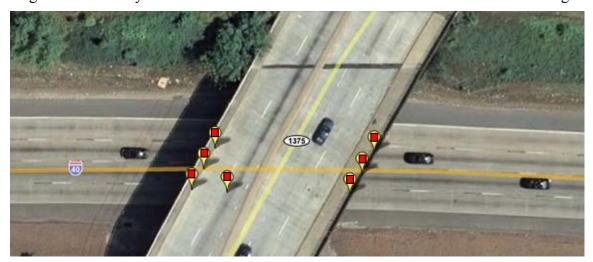
Figure 4.16. Terrametrix measurement locations for Lake Wheeler Road bridge.
